# The April 16 2016 M<sub>w</sub>7.8 Muisne Earthquake in Ecuador – Preliminary Observations from the EEFIT Reconnaissance Mission of May 24 - June 7

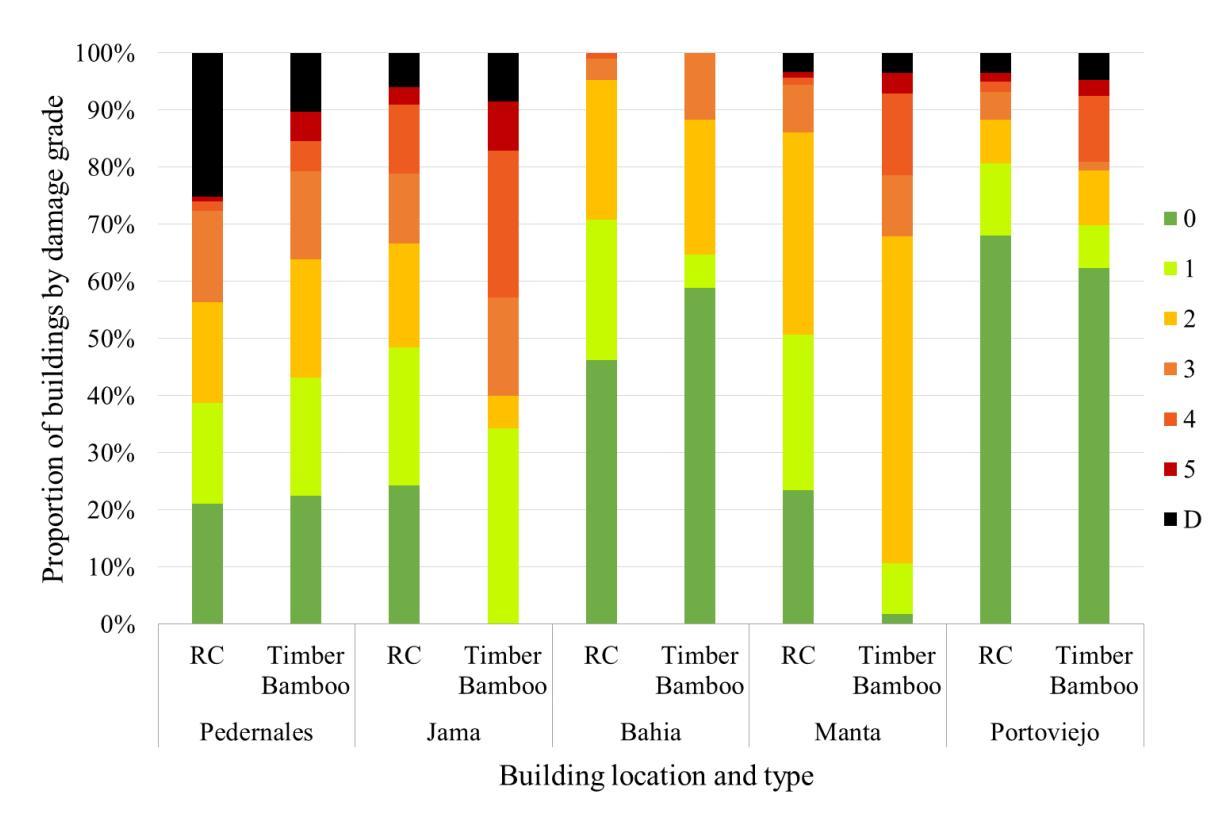
Figure 2 – Damage survey results by area and by EMS-98 damage grade ("D" denotes demolished).

The proportion of buildings surveyed at different damage states is summarised in Figure 2. Even considering the caveats above, Figure 2 indicates that RC buildings experienced greater levels of damage than timber/bamboo buildings, and in addition that Pedernales experienced the greatest level of damage out of the towns the team visited.

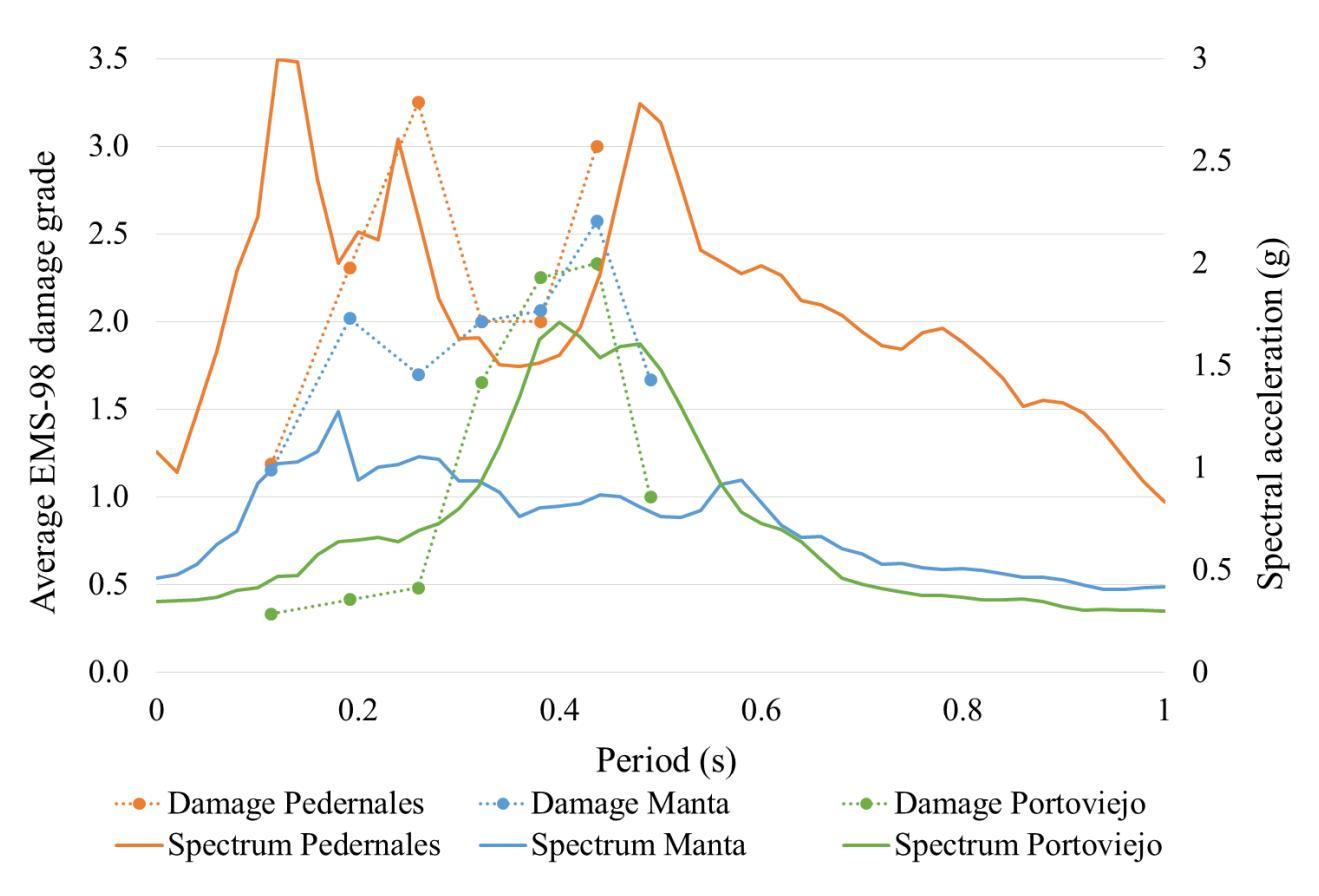
Figure 3 – Relationship between response spectra from recorded ground motions [14] and surveyed damage.

Figure 3 compares the spectral accelerations recorded at stations in Pedernales, Manta, and Portoviejo, with the average damage grades of RC and timber/bamboo structures of different heights surveyed in those locations whose fundamental periods are estimated using Eurocode 8 [15]. In Portoviejo the damage correlates well, and similarly in Pedernales except for the first peak (at just over 0.1s). For Manta, the correlation is weaker although it is difficult to tell without any major peaks in the recorded spectral acceleration. This comparison tends to confirm the expected relationship between shaking frequency and damage to structures of certain height.

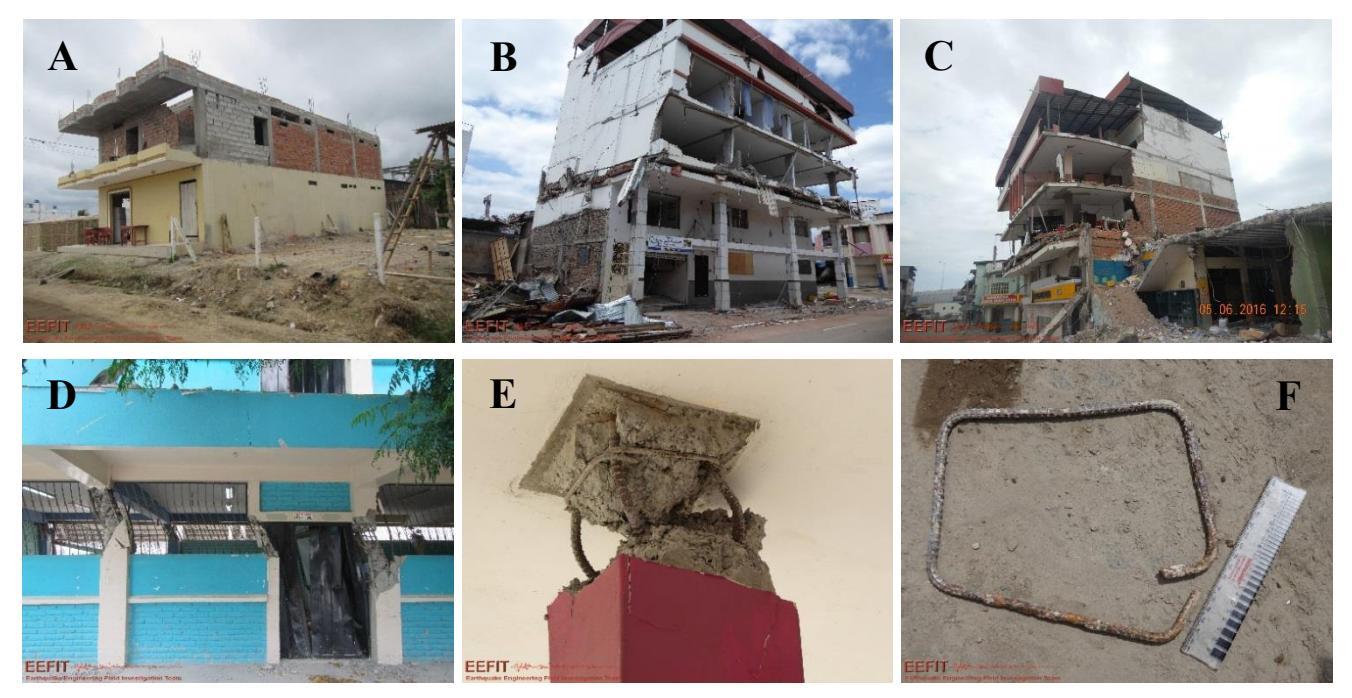
**Failure at upper levels**: Upper floor soft/weak storey failures were observed in a number of buildings. It is suspected that this could be due to constructing upper floors long after the bottom floors are completed (as extensions of the building when new resources become available or when new needs arise; see Figure 4A). The joints between new and old are typically poorly executed with insufficient lapping of the rebar, resulting in local reduction in capacity promoting failure in these areas (Figure 4B). This localised upper storey damage may also be attributed to all rebar being lapped at one height, resulting from the use of the same length bars in all

columns. Additionally, some upper storey failures could be attributed to changes in plan or elevation at specific levels, resulting in a weak/soft storey.

**Inadequate design and detailing of RC moment frames**: RC moment frames in seismic areas require several key considerations to ensure they behave safely in an earthquake: 1) Sufficient overall moment and shear capacity, 2) Columns' flexural strength should exceed that of the beams, such that flexural failure occurs first in the beams, 3) Columns and beams should be stronger in shear than in flexure, such that a ductile flexural failure mode occurs before a brittle shear failure mode, and 4) Adequate detailing of the reinforcement in all elements. Damaged RC structures observed generally failed some or all of these requirements (see Figure 4C).

Figure 4 – Two-storey building with columns' rebar left sticking out of roof for future extension (A). Weak/soft storey failure at upper level (B). Inadequate design/detailing of RC frame and infills (C). School building with short column failure (D). Column head failure showing insufficient and poor shear design and detailing (E). Column link with no 135°-bend (F).

**Short columns**: This failure mode was seen in a number of buildings, with a reoccurring detail of high level windows for the full length of the frame bays (see Figure 4D).

**Inadequate design and detailing for shear**: In many RC buildings surveyed there was poor detailing of shear reinforcement, with sparsely-spaced links and with poor/no anchorage of these links into the columns (i.e. no 135°-bends in links; see Figures 4E & 4F).

- Improved knowledge and application of basic fundamental structural and seismic design principles
- Better reinforcement detailing, notably detailing of links and rebar overlaps, and increased cover
- Better masonry infill walls and bed joints, better seismic connections to frames, and better materials
- Superior construction quality standards, especially concrete
- Better building maintenance, especially for timber or bamboo structures

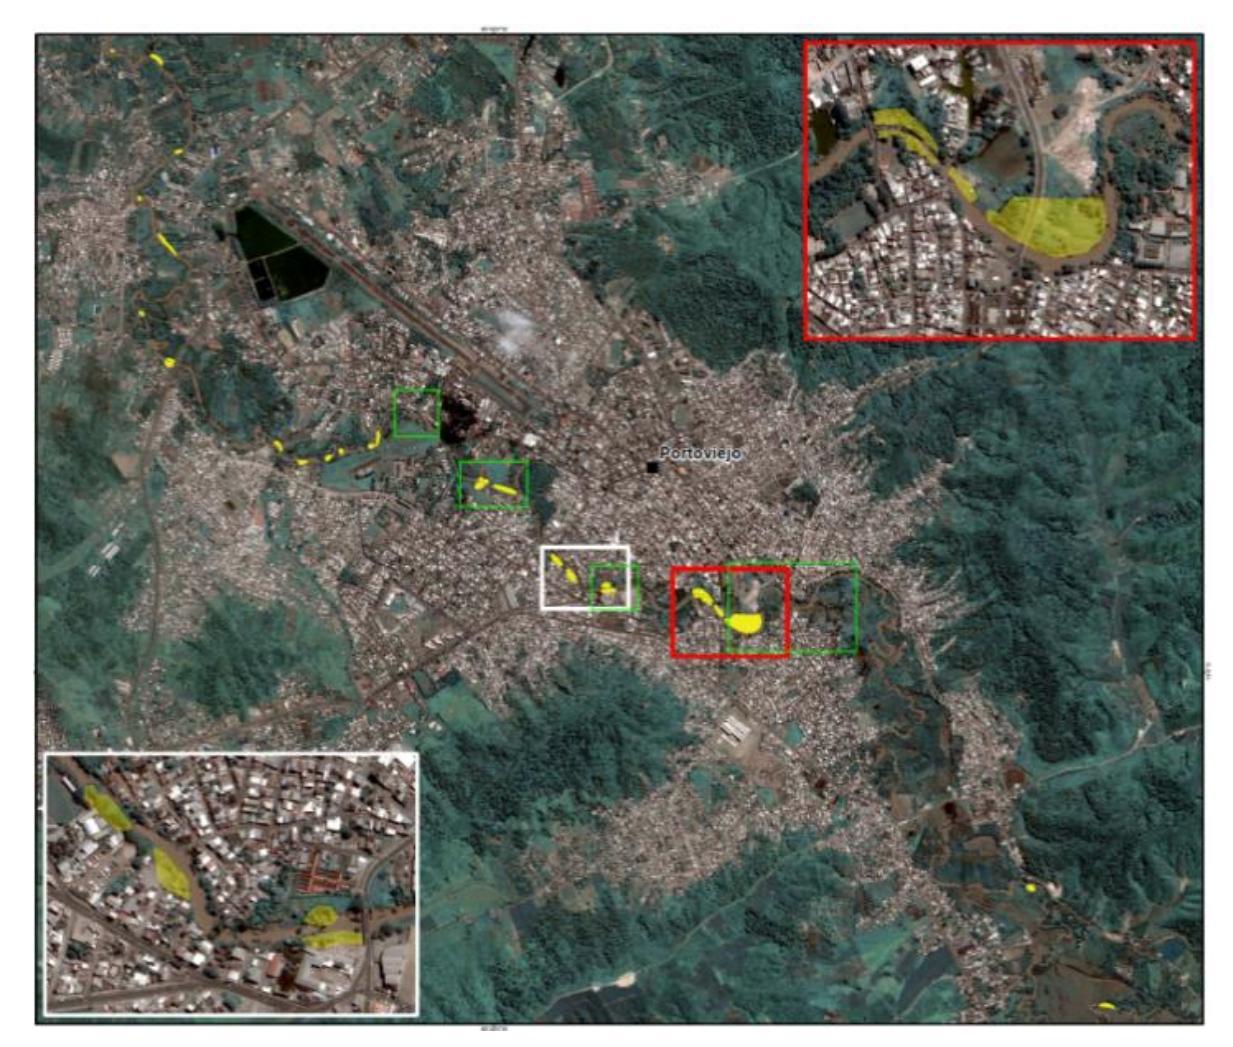
Figure 5 - Portoviejo landslides (in yellow) identified from satellite imagery (British Geological Survey).

As part of the team's landslide reconnaissance, a ground-truthing exercise was undertaken in collaboration with the British Geological Survey (BGS) to provide field validation for their preliminary landslide assessment, initiated by a request from the UK Department for International Development (DfID) and based on satellite imagery from UNITAR/UNOSAT [17]. Photographic and drone imagery were taken on site and interviews were conducted at locations of identified landslides. 13 sites were surveyed in Portoviejo [18] and 17 in the vicinity of Bahía de Caráquez [19] as part of this exercise. Guided by the BGS satellite images, the team visited these locations and provided observations (see Figure 5 & Table 1 as an example for Portoviejo).

During the survey, the team confirmed that the satellite-imagery interpretation had been mostly successful in correctly identifying landslides in the areas surveyed. A few small-scale additional landslides to those mapped in the rapid co-seismic preliminary assessment were observed and a couple of locations associated to greater uncertainty in the assessment were confirmed not to correspond to landslides after all. On the other hand, satellite-based analysis made it possible to identify extensive landslides attributed to liquefaction mapped along the Chone Estuary, close to Bahía de Caráquez, that were difficult to access due to dense vegetation and instable soil boundaries. Following the map and talking to the local community, the team was able to corroborate the preliminary assessment, observing signs of landslides such as drift of trees in the estuary.
