Landslides in Bangladesh & Future Planning

BANGLADESH INSTITUTE OF PLANNERS BIP

Presented by-PLANNER BAYES AHMED

National Press Club, Dhaka, Bangladesh 21 June 2017

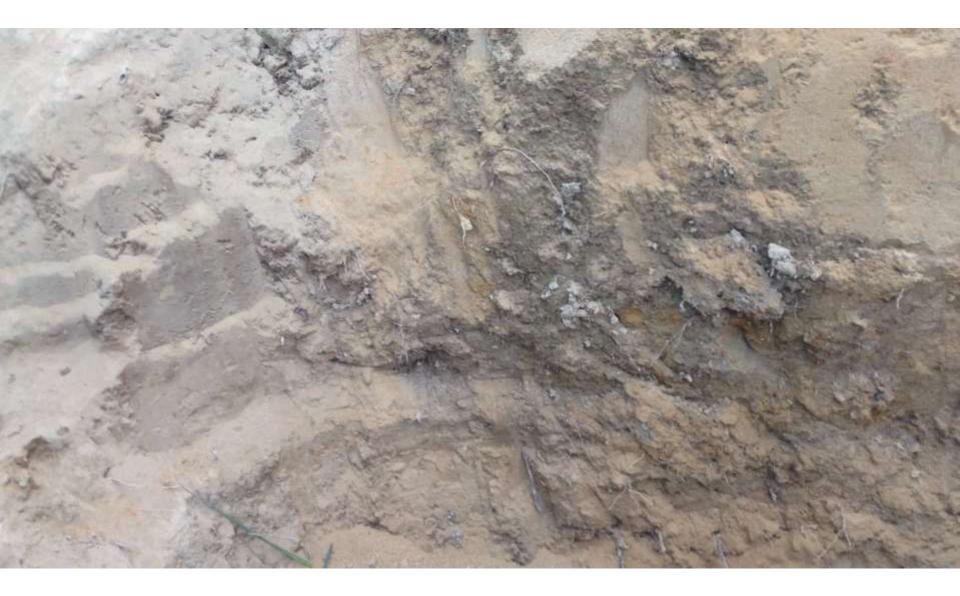
Hill Cutting
